LAKE MARIE DAM

MERCER COUNTY, MISSOURI

MO 10154

PHASE 1 INSPECTION REPORT  
NATIONAL DAM SAFETY PROGRAM

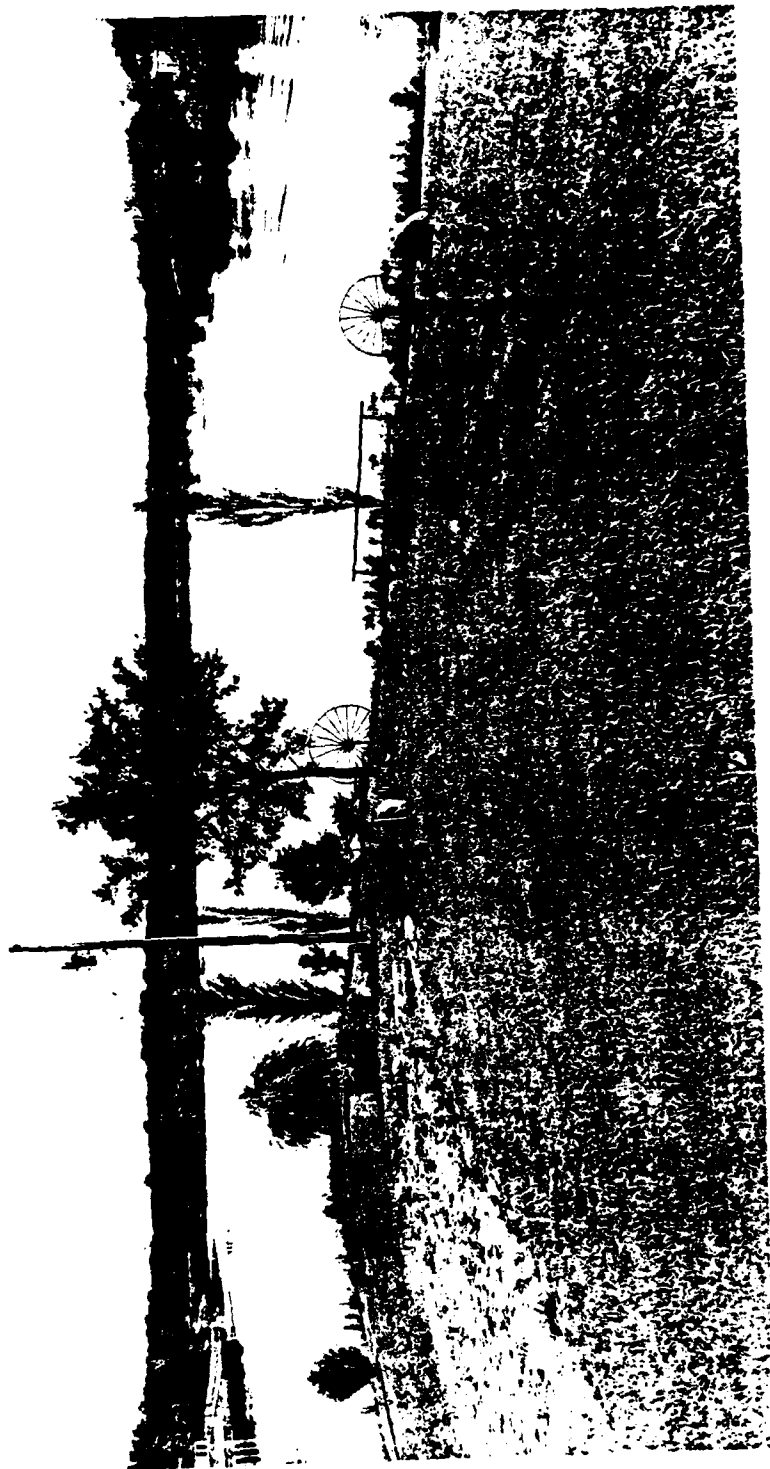
PHOTOGRAPH NO. 1  
OVERVIEW  
LOOKING SOUTH  
TO DAM

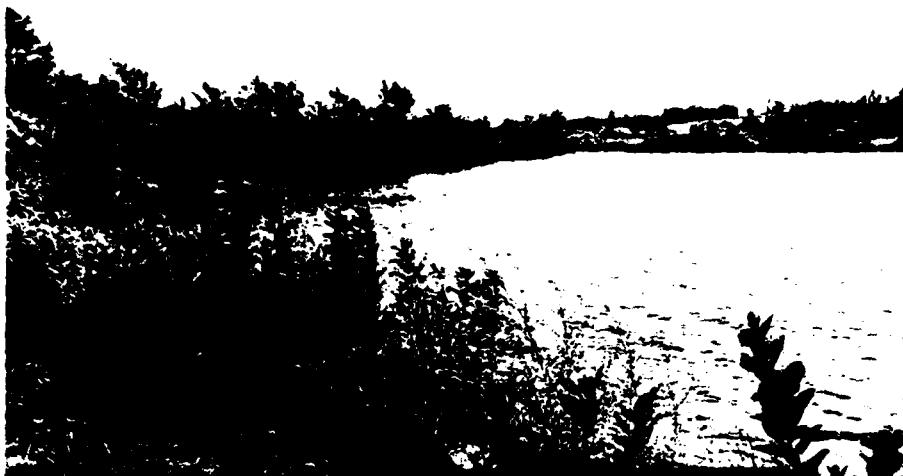
PHOTO NO. 2  
UPSTREAM SLOPE  
FROM EAST  
ABUTMENT

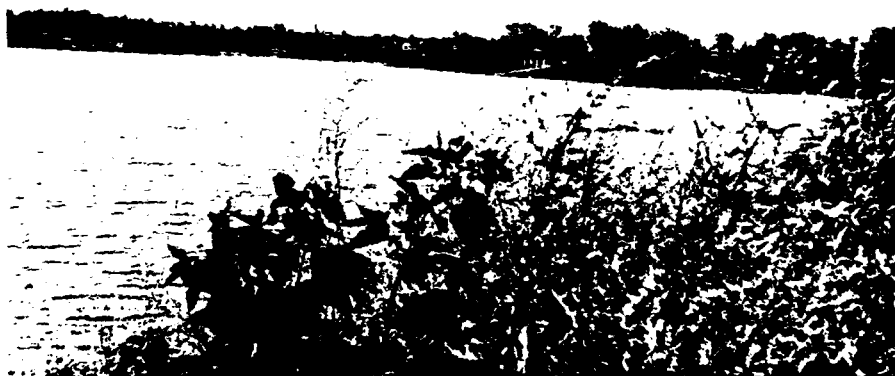
PHOTO NO. 3  
LOOKING UPSTREAM  
TO NORTHEAST  
FROM CENTER OF DAM

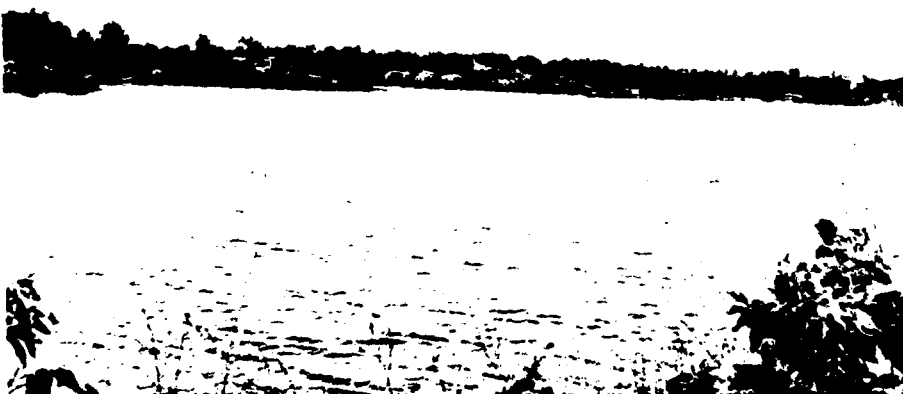
PHOTO NO. 4  
LOOKING UPSTREAM  
TO NORTH FROM  
CENTER OF DAM

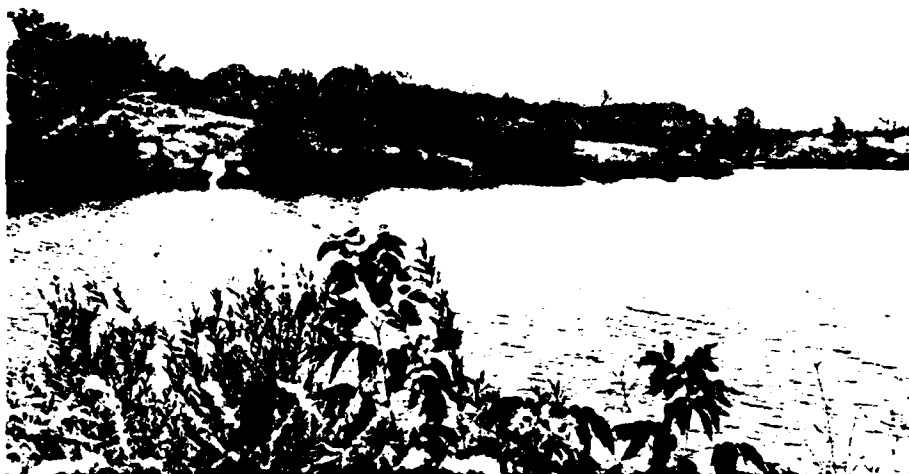
PHOTO NO. 5  
LOOKING UPSTREAM  
TO NORTHWEST  
FROM CENTER OF DAM

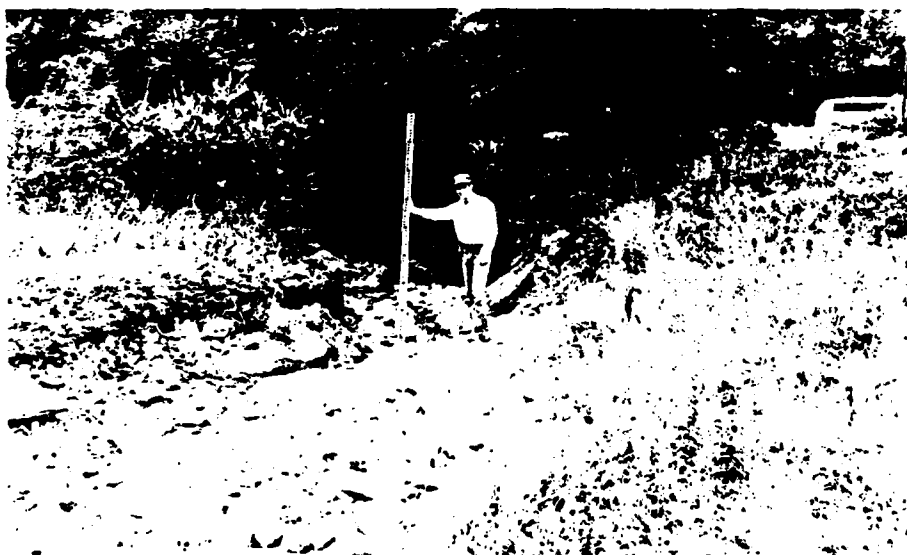
e. Downstream Channel. The bottom of the outfall or exit section of the spillway is plated with loose limestone rock for a distance of about 50 feet downstream from the centerline of the dam. Below this point the channel is badly eroded into silty and sandy clay materials. The eroded channel extends for a distance of 300 feet  $\pm$  where it passes under an access road and discharges into Hidden Valley Lake some 600 feet downstream from Lake Marie.

(2) The spillway exit channel is plated with loose limestone rock for 50± feet below center line of dam but is badly eroded below that.

PHOTO NO. 7  
LOOKING DOWN  
EMERGENCY SPILLWAY  
FROM CENTERLINE  
OF DAM

(2) The size of the spillway and/or the height of the dam should be increased to pass the probable maximum flood without overtopping the dam. If the height of the dam is increased, additional investigations and analyses should be conducted to determine the structural characteristics and stability of the present embankment. Seepage analyses should be conducted. The services of an engineer experienced in the design of dams should be obtained to evaluate the present dam and to design the new structure and/or a spillway that is adequately sized and stable with respect to erosional damage.

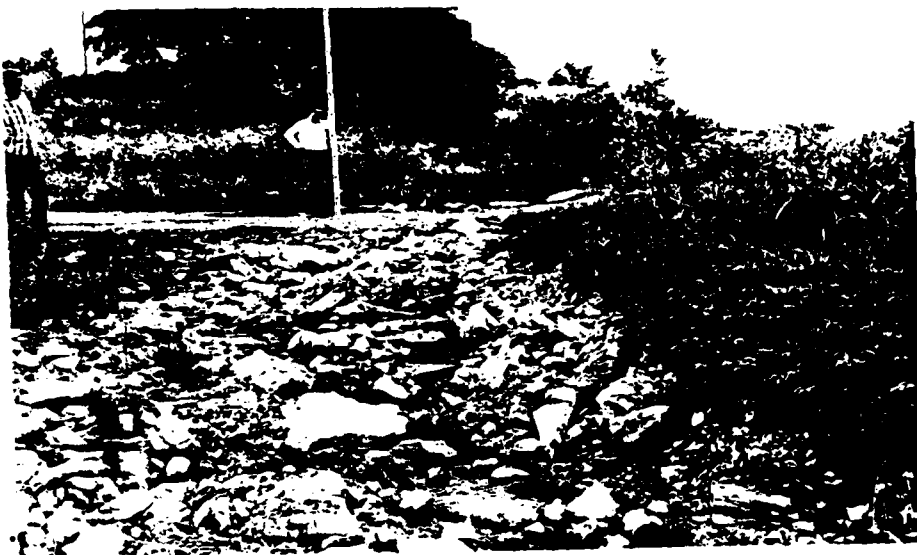
PHOTO NO. 8  
LOOKING UPSTREAM  
IN EMERGENCY SPILLWAY

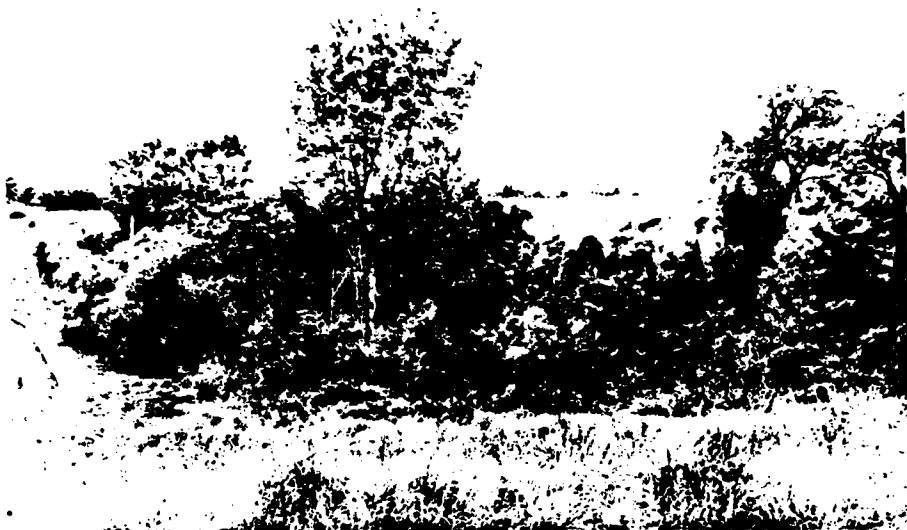
b. Dam. A number of trees up to 6 inches in diameter are growing on the upstream slope. No slides or serious erosion was noted on the upstream slope. The downstream slope of the dam was covered with a dense growth of trees, shrubs, briars, and sweet clover. No seeps or slides were noted on the downstream slope but the dense growth made it difficult to determine the condition of this section of the embankment.

PHOTO NO. 11  
LOOKING AT  
DOWNSTREAM  
SLOPE

- (1) Clear the dam of uncontrolled growth of trees and shrubs.

(1) A program should be developed and put into action to keep trees and brush off of the dam and to control other vegetation.

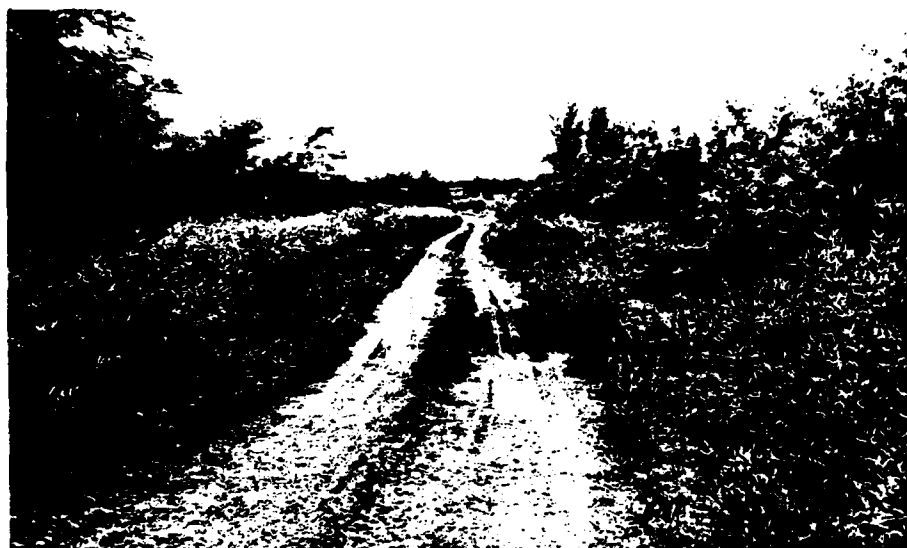
Rough measurements along the centerline of the dam indicate that the left (east) end of the embankment is 6 ft.  $\pm$  higher in elevation than the right (west) end. This is shown on the centerline profile in Appendix C.

PHOTO NO. 12  
CREST OF DAM  
TAKEN FROM EAST  
LOOKING WEST
